# SWAN HILL WTP “POOLIFIER”

David Girdwood <sup>1</sup>, Craig Jakubowski <sup>2</sup>, Junior Kelly <sup>1</sup>

1. Lower Murray Water, Swan Hill, VIC, Australia

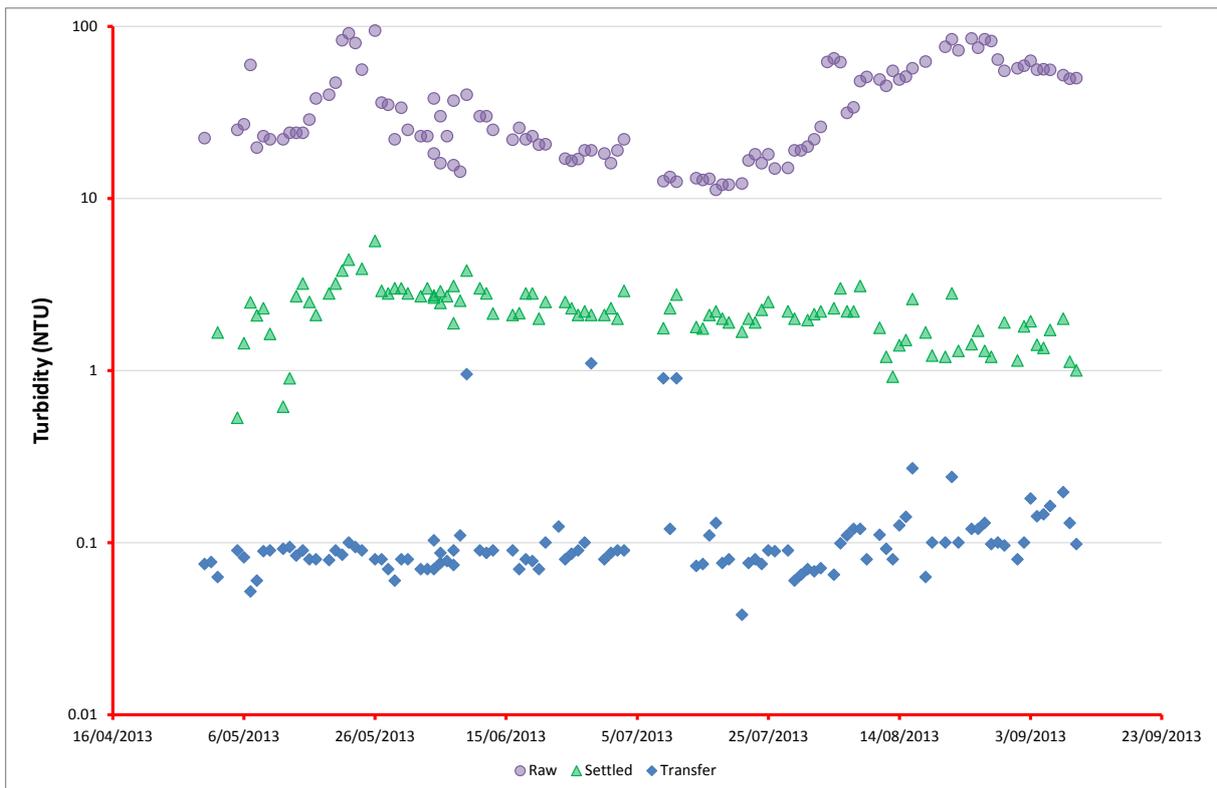
Figure 7: Swan Hill WTP raw, settled and transfer water turbidity during continuous Poolifier operation (30th April to 9th September 2013).

The Poolifier was operated in a continuous mode of operation from 30<sup>th</sup> April to 9<sup>th</sup> September 2013. During this time the plant was operated in automatic mode, starting and stopping based on the level of treated water in the distribution network. Table 2 gives the settled and transfer (combined filtered) turbidity during the operation period. Figure 7 graphically presents the raw, settled and transfer turbidity during the operational period.

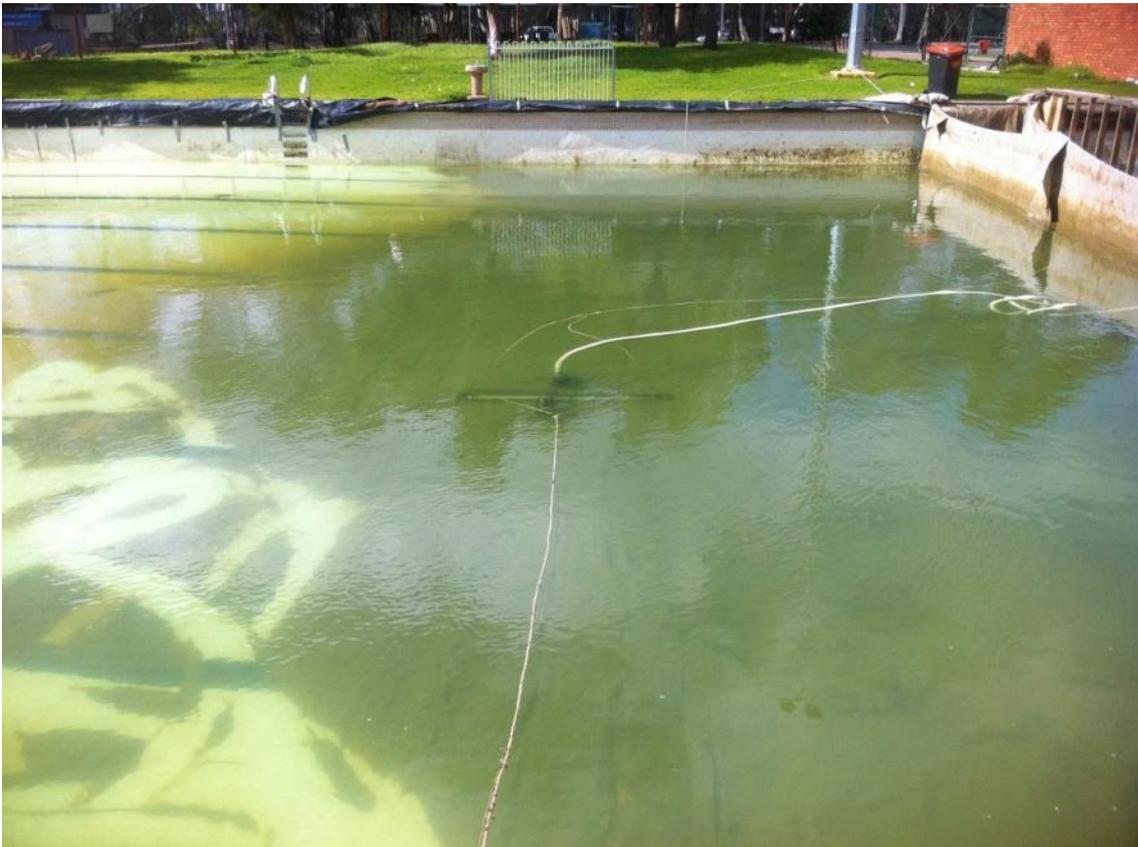
*Figure 9. Sludge removal.*

A pool cleaner head was coupled to a pump for suction of sludge from the tank. Operational staff moved the head around the pool for sludge removal, with the sludge discharged to sewer.

The majority of the sludge removal proces was undertaken manually throughout operation. It was found that the majority of solids settled quickly and hence accumulated in the first half of the pool, with much of it around the flocculation structure itself. In fact the solids retention in the sections around the 10 m x 10 m flocculation structure almost acted as a sludge blanket, with flocculated water undergoing further solids contact in this zone. Lighter solids that did travel further up the pool that settled to the bottom were removed by an automatic pool cleaning type device. Rather than waste this water to sewer, it was instead returned to the flocculation structure.
